USAAVLABS TECHNICAL REPORT 69-92

HOT CORROSION RESISTANCE OF MATERIALS FOR SMALL GAS TURBINE RECUPERATORS

December 1969

**THE GARRETT CORPORATION
AIRESEARCH MANUFACTURING COMPANY
LOS ANGELES, CALIFORNIA**

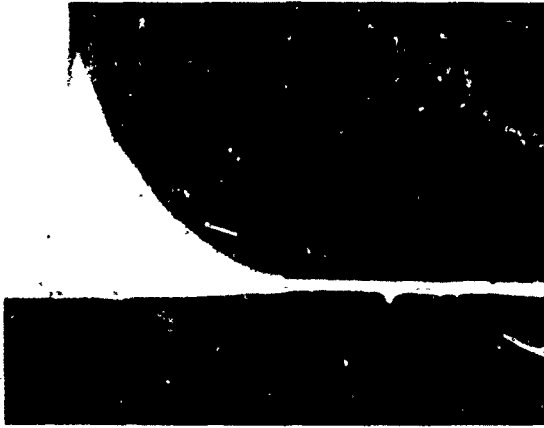
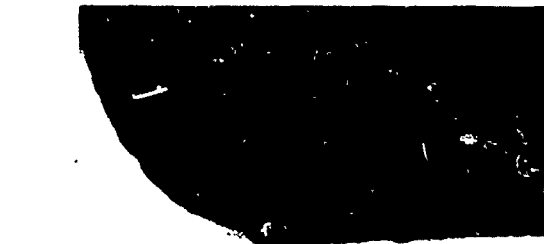
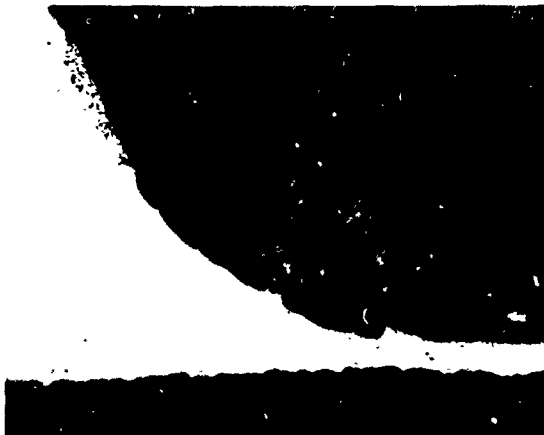
Figure 114. Photomicrographs of Type 347 Stainless Steel Tubes Brazed With Palniro 7 Brazing Alloy.

1100°F AND 35 KSI, FAILED AFTER 57.2 HOURS

1100°F AND 30 KSI, FAILED AFTER 250.1 HOURS

1100°F AND 26.9 KSI, FAILED AFTER 1238.7 HOURS

1300	8.0	486.4	P	-1/4	H	Heavy oxide layer, particularly at interface	Heavy oxide layer, metal 1.0 mil thick	113		
1300	8.0	465.4	R	+1	H	Heavy oxide layer, particularly at interface	Heavy oxide layer, metal 0.5 mil thick	113		
1100	35	57.2	R	±1	S	No corrosion	Metal thinning, slight corrosion	114		
1100	30	250.1	P	-2	S	No corrosion	Slight oxide layer	114		
1100	26.9	1238.7	P	+1/4	M	Some intergranular corrosion	Oxide layer 1.0 mil thick	114		
1100	26.9	461	P	J	M	No corrosion	Heavy oxide layer, complete penetration	-		
*P = Pinhole leak; R = Tube rupture; J = Braze joint; + = Above J; - = Below J; S = Slight; M = Moderate; H = Heavy

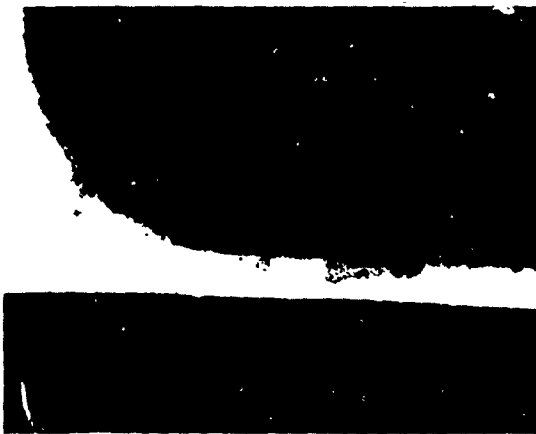
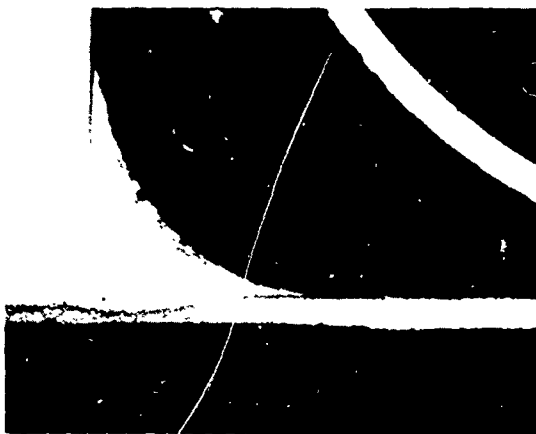
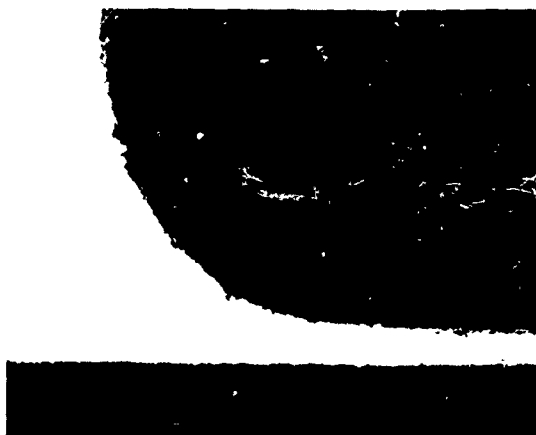
Figure 116. Photomicrographs of Type 347 Stainless Steel Tubes Brazed With Microbraz 135 Brazing Alloy.

1500°F AND 3.0 KSI, FAILED AFTER 17.4 HOURS

1300°F AND 13.9 KSI, FAILED AFTER 82.7 HOURS

1300°F AND 13.9 KSI, FAILED AFTER 107.7 HOURS

TABLE XXXIII. TYPE 347 STAINLESS STEEL BRAZED WITH MICROBRAZ 135, FAILURE AND CORROSION EXAMINATION										
Temperature. (°F)	Stress (ksi)	Life (hr)	Visual Examination*			Metallographical Examination		Photomicrograph Figure No.		
			Failure Type	Location	Corrosion	Braze Alloy Fillet	Point of Failure			
1500	9.2	35.0	P	-1/2	M	Some surface porosity	Heavy oxide layer 1-1/2 mils thick, intergranular oxidation	115		
1500	9.2	125.1	P	-1	H	No corrosion	Thin layer, little attack	115		
1500	5.0	170.2	P	+1	H	No corrosion	Heavy oxide layer 1-1/2 mils thick, complete intergranular penetration	115		
1500	3.0	77.4	P	-3	H	Moderate intergranular corrosion	Heavy oxide layer, 2-1/2 mils thick, some intergranular attack	116		
1300	13.9	82.7	R	-3	M	Some surface porosity	Shallow oxide layer, deep intergranular oxidation	116		
1300	13.9	107.7	P	-3/4	M	Slight oxide layer	Moderate oxide layer, intergranular penetration	116

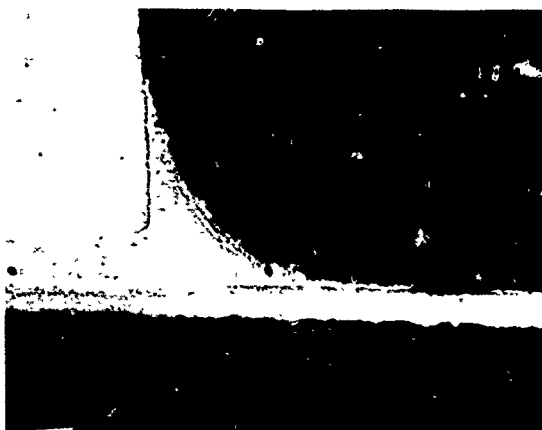
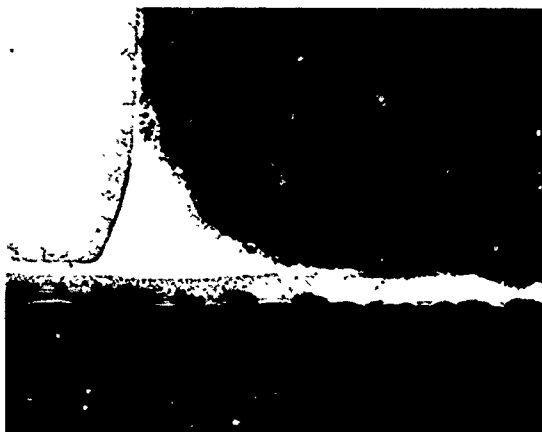
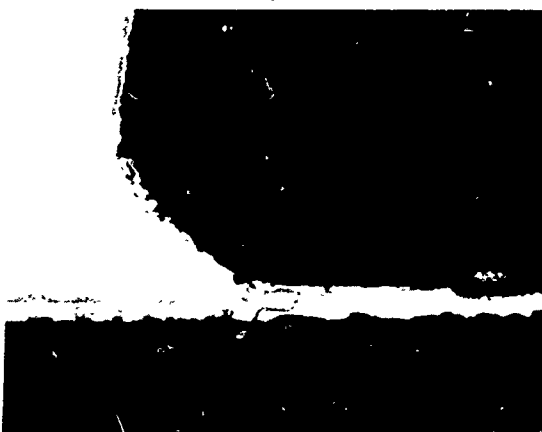
Figure 117. Photomicrographs of Type 347 Stainless Steel Tubes Brazed With Microbraz 135 Brazing Alloy.

1300°F AND 10.0 KSI, FAILED AFTER 441.2 HOURS

1300°F AND 8.0 KSI, FAILED AFTER 676.7 HOURS

1300°F AND 8.0 KSI, FAILED AFTER 578.5 HOURS

1300	10.0	441.2	P	-1	H	No corrosion	Heavy oxide layer 1-1/2 mils thick, some intergranular oxidation	117		
1300	8.0	676.7	P	-2	H	Slight intergranular oxidation	Heavy oxide layer	117		
1300	8.0	578.5	P	+2	H	Some intergranular oxidation	Heavy oxide layer 1-1/2 mils thick	117		
1100	35.0	228.1	P	J	S	No corrosion	Oxide layer 1 mil thick, oxidized fissure	118		
1100	30.0	248.8	P	+1	S	No corrosion	Thin oxide layer	118		
1100	26.9	1023.1	P	+1/2	M	No corrosion	Thin oxide layer	118

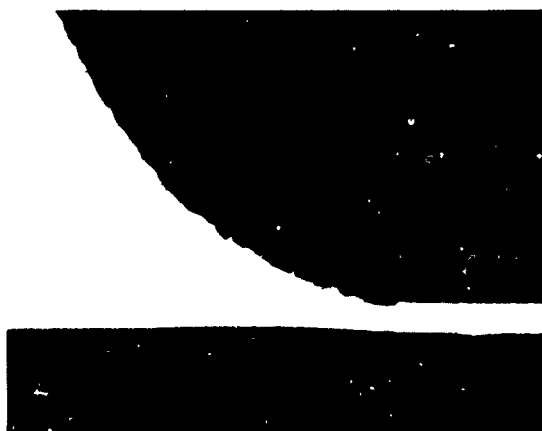
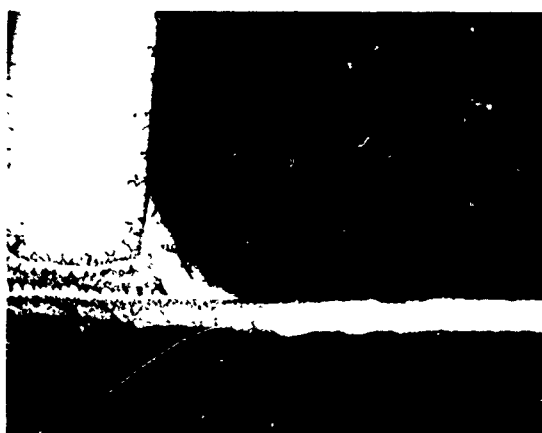
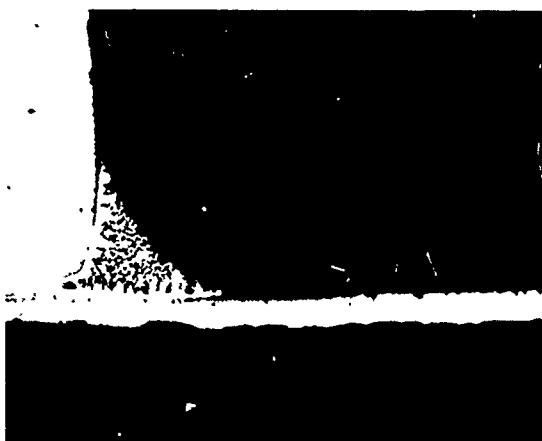
Figure 118. Photomicrographs of Type 347 Stainless Steel Tubes Brazed With Microbraz 135 Brazing Alloy.

1100°F AND 35 KSI, FAILED AFTER 228.1 HOURS

1100°F AND 30 KSI, FAILED AFTER 248.8 HOURS

1100°F AND 26.9 KSI, FAILED AFTER 1023.0 HOURS

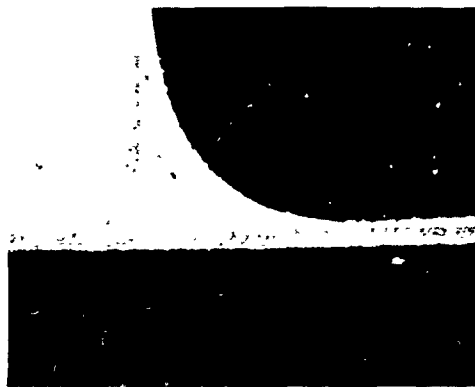
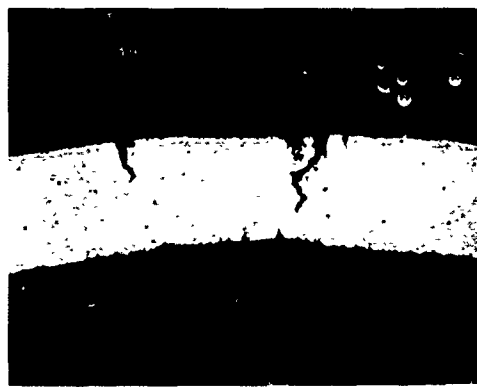
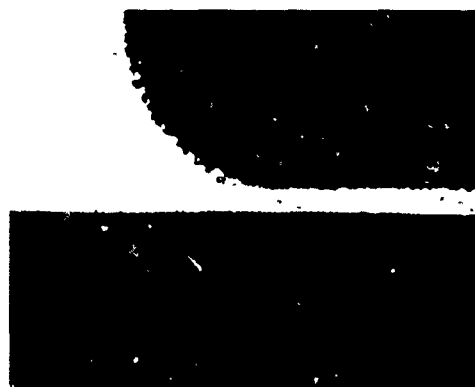
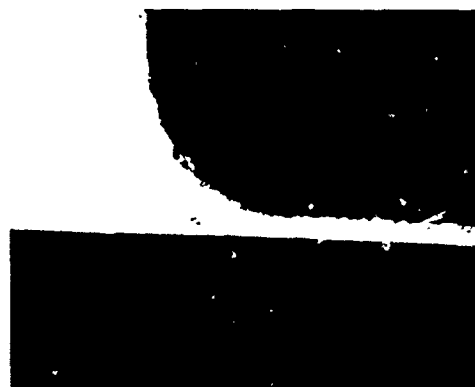
Figure 119. Photomicrographs of Inconel 625 Tubes Brazed With Microbraz 135 Brazing Alloy.

MAG = X75

MAG = X250

1500°F AND 12.1 KSI, FAILED AFTER 89.5 HOURS

1500°F AND 8.7 KSI, FAILED AFTER 230.0 HOURS

1500°F AND 6.6 KSI, FAILED AFTER 570.0 HOURS

TABLE XXXIV. INCONEL 625 BRAZED WITH MICROBRAZ 135, FAILURE AND CORROSION EXAMINATION									
Temperature (°F)	Stress (ksi)	Life (hr)	Visual Examination*			Metallographical Examination		Photomicrograph Figure No.	
			Failure		Corrosion	Braz Alloy Fillet	Point of Failure		
			Type	Location					
1500	12.1	89.5	P	-1/2	H	No corrosion, no alloy penetration	Oxidation along boundaries at failure site	119	
1500	8.7	230.4	P	-1	H	Slight corrosion, no alloy penetration	Oxidation along boundaries at failure site, oxide film 0.5 mil thick	119	
1500	6.6	570.4	P	-1	H	Slight corrosion, no alloy penetration	Oxidation along grain boundaries at failure site	119	
1300	33.0	169.2	P	-2	S	No corrosion, no alloy penetration	Oxidized grain boundaries along stress-rupture fissure	120	
1300	26.0	675	P	+1/2	S	Slight corrosion, no alloy penetration, small fillet	Oxidized grain boundaries and fissure face	120	
1300	19.1	160.5	**		H	Slight corrosion, no alloy penetration	No grain boundary oxidation, slight oxide layer 0.1 mil thick	120

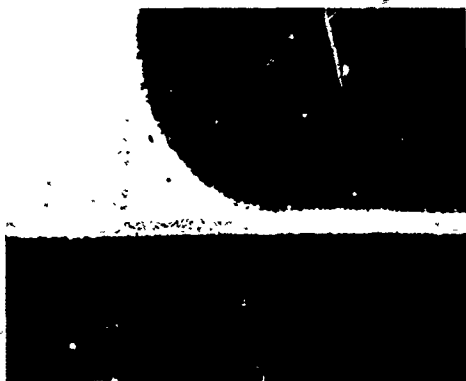
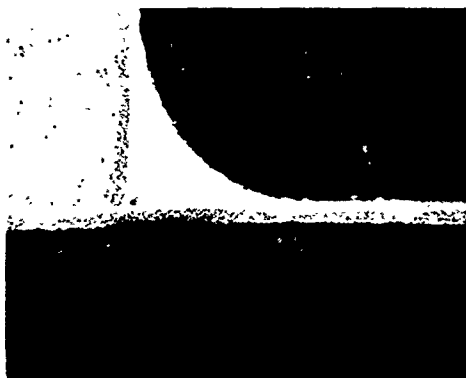
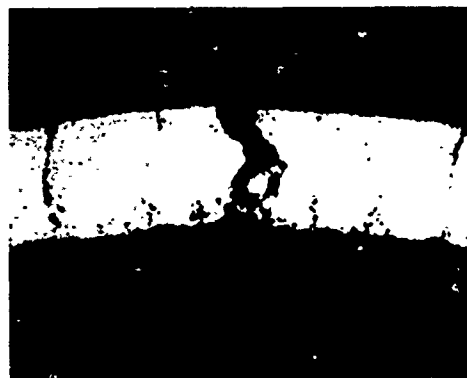
Figure 120. Photomicrographs of Inconel 625 Tubes Brazed With Microbraz 135 Brazing Alloy.

MAG = X75

MAG = X250

1300°F AND 33 KSI, FAILED AFTER 169.0 HOURS

1300°F AND 26 KSI, FAILED AFTER 675.0 HOURS

1300°F AND 19.1 KSI, NO FAILURE AFTER 1605.0 HOURS

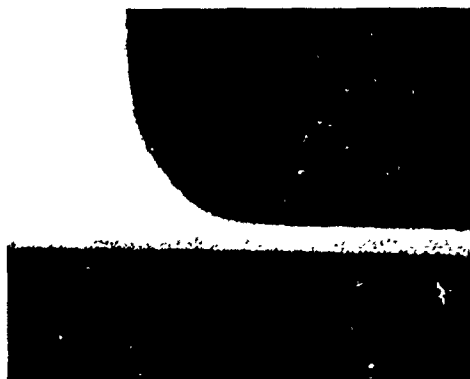
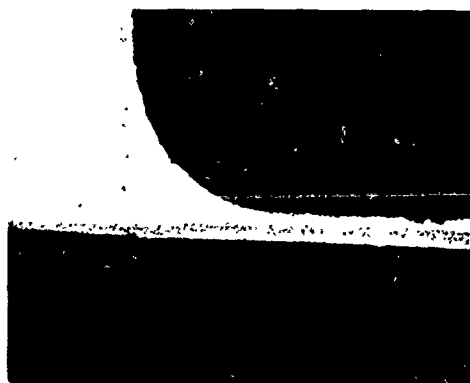
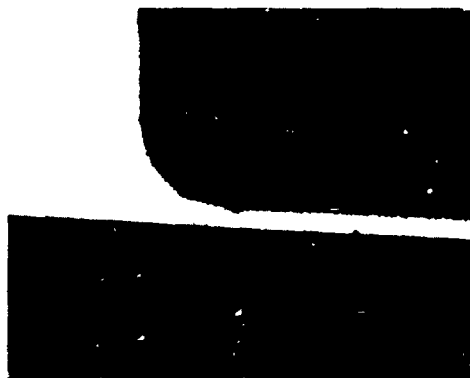
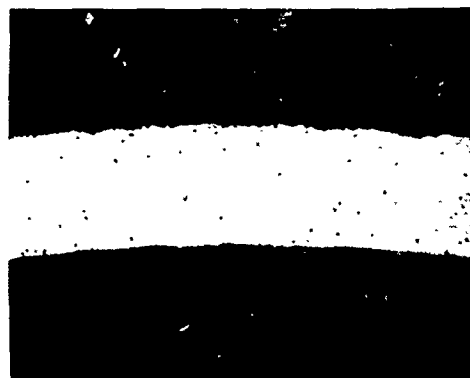
MAG = X75

MAG = X250

1200°F AND 50.4 KSI, FAILED AFTER 56.0 HOURS

1200°F AND 46.4 KSI, FAILED AFTER 394.0 HOURS

1200°F AND 34.7 KSI, FAILED AFTER 1610.0 HOURS

1200	50.4	56.6	P	+1/2	S	No corrosion, no alloy penetration, small fillet	No oxidation observed	121	
1200	46.4	394.6	**	-	S	No corrosion, slight alloy penetration, small fillet	Discontinuous oxide layer 0.2 mil thick	121	
1200	40	655.6	P	-1	S	No corrosion, no alloy penetration, small fillet	No oxidation observed	121	
1200	34.7	1610	**		S	No corrosion, slight alloy penetration, small fillet	Discontinuous oxide layer 0.2 mil thick	121	
*P = Pinhole leak; R = Tube rupture; J = Braze joint; + = Above J; - = Below J; S = Slight; H = Moderate; H = Heavy; **No failure

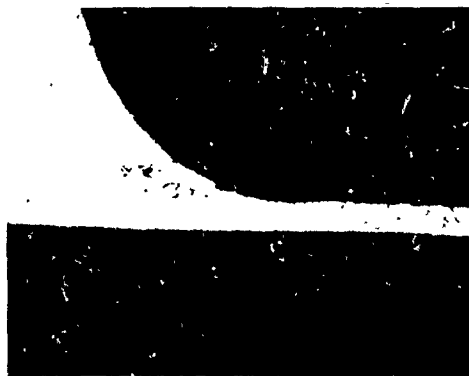
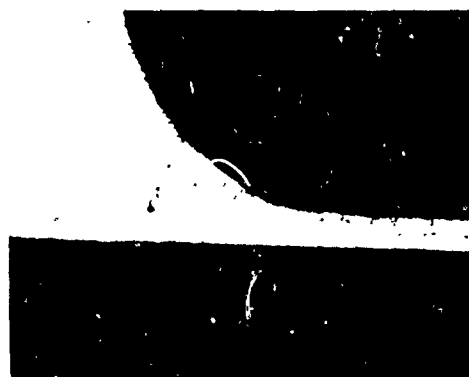
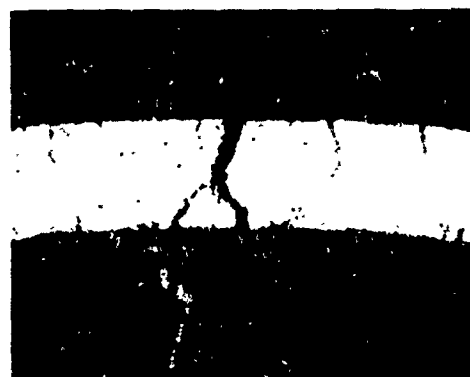
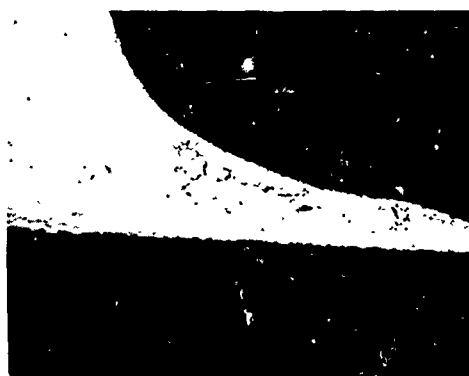
Figure 122. Photomicrographs of Inconel 625 Tubes Brazed With J-8100 Brazing Alloy.

MAG = X75

MAG = X250

1500°F AND 12.1 KSI, FAILED AFTER 146.0 HOURS

1500°F AND 8.7 KSI, FAILED AFTER 209.0 HOURS

1500°F AND 6.6 KSI, FAILED AFTER 570.0 HOURS

Temperature (°F)	Stress (ksi)	Life (hr)	Visual Examination*			Metallographical Examination		Photomicrograph Figure No.
			Failure		Corrosion	Brazed Alloy Fillet	Point of Failure	
			Type	Location				
1500	12.1	146.3	P	-1	H	No oxidation, complete penetration	Grain boundaries oxidized at failure site, no oxide on surface layers	122
1500	8.7	208.9	P	-1-1/2	H	No oxidation, complete penetration	Very thin surface oxide layer, grain boundary oxidation at failure site	122
1500	6.6	570.4	P	-	H	Slight intergranular oxidation, complete penetration	Very thin surface oxide layer, grain boundary oxidation at failure site	122
1300	33.0	158.1	P	-1/2	S	No oxidation, complete penetration of tube wall by brazing alloy	No oxidation observed	123
1300	26.0	843.4	P	-2	H	Some oxidation observed, complete penetration	Some oxidation along stress-rupture fissure	123
1300	19.1	1604	**		H	Slight oxidation of brazing alloy, complete penetration	Oxide film 0.2 mil thick observed, very slight intergranular penetration	123

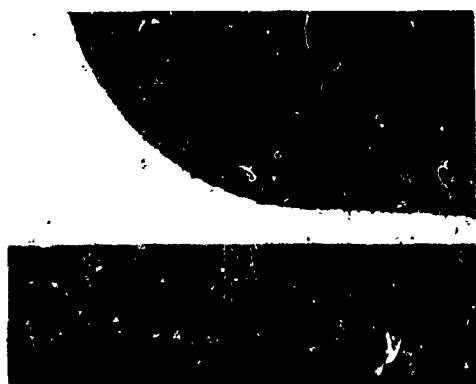
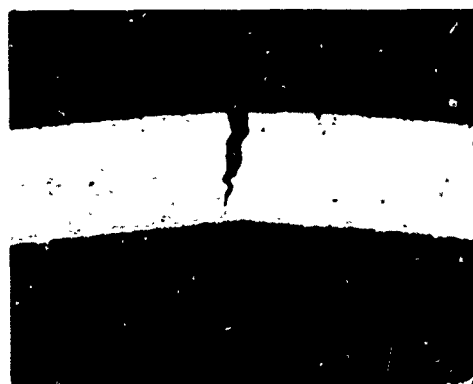
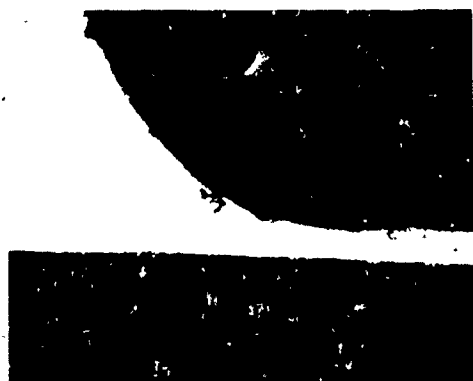
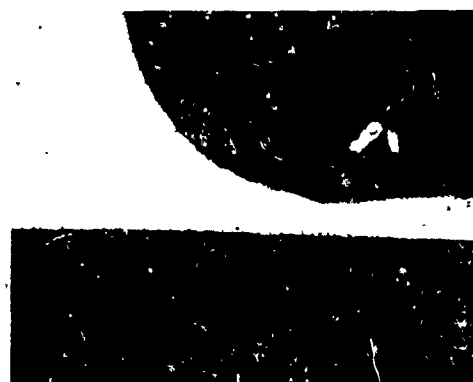
Figure 123. Photomicrographs of Inconel 625 Tubes Brazed With J-8100 Brazing Alloy.

MAG = X75

MAG = X250

1300°F AND 33.0 KSI, FAILED AFTER 158.0 HOURS

1300°F AND 26.0 KSI, FAILED AFTER 843.0 HOURS

1300°F AND 19.1 KSI, FAILED AFTER 1604.0 HOURS

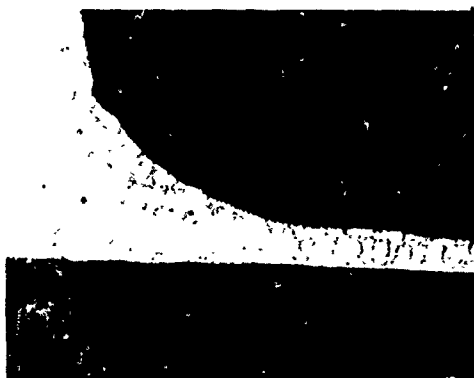
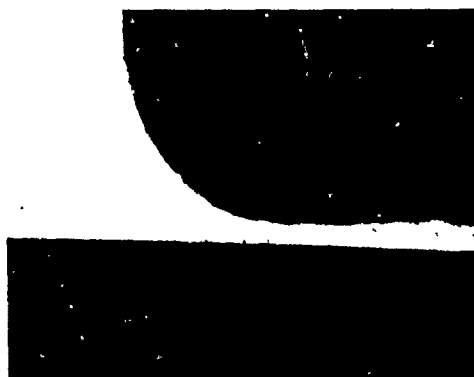
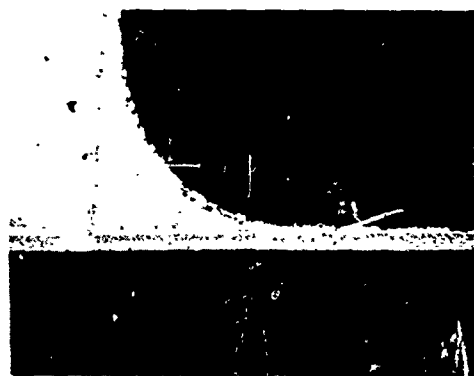
MAG = X75

MAG = X250

1200°F AND 50 KSI, FAILED AFTER 43.0 HOURS

1200°F AND 41.0 KSI, FAILED AFTER 955.0 HOURS

1200°F AND 35.0 KSI, FAILED AFTER 1610.0 HOURS

1200	50.4	43.0	P	-1/2	S	No corrosion, complete penetration of tube by brazing alloy, good filletting	No oxidation observed	124
1200	46.4	394.6	**	-	S	No corrosion, complete penetration of tube by brazing alloy, good filletting	No oxidation observed	124
1200	41.0	955.1	**	-	S	No corrosion, 50 percent penetration of tube by brazing alloy, good filletting	No oxidation observed	124
1200	35.7	1610	**	-	S	Slight oxidation of brazing alloy, good filletting	Very slight oxidation detected (0.1-mil)-thick oxide film	124
